Overview

version 1.2 | 17 October 2022

We have produced this document to help the public and other parties understand what we maintain and why.

We have taken an evidence-based approach using detailed hydraulic modelling. Flooding in Rhyl and Prestatyn is complex and can be from many sources. While river maintenance generally reduces flood risk, there are places where channel maintenance in one area could make flooding worse in another area.

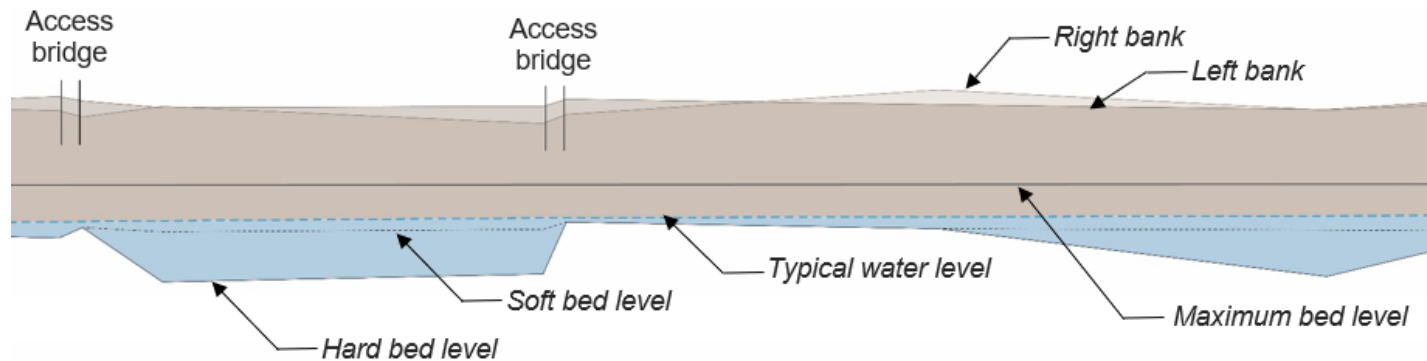
A long section is provided on the maintenance summary sheet for each reach (except R3 and P8 where not available). See example long section below with key features. The right and left bank are as viewed when looking downstream.

Current soft riverbed levels (top level of soft silt/sand) and hard riverbed levels (top level of hard gravels/rock) are generally based on the most recent topographical survey undertaken in 2018, with older data used to infill gaps. The long sections may therefore not be fully up to date, but a selection of spot checks was undertaken at key locations in 2021.

The maximum bed level is the highest level that the surface of the soft bed can reach before there is a significant impact on flooding of properties. We will monitor riverbed levels and will plan removal of riverbed material when the maximum bed level is reached.

In many places drainage into the watercourses could be affected by silt levels. In these locations, the maximum bed level is often set by the invert level of outfalls. The main outfalls into the watercourses are shown on the long sections but not all outfalls have been surveyed.

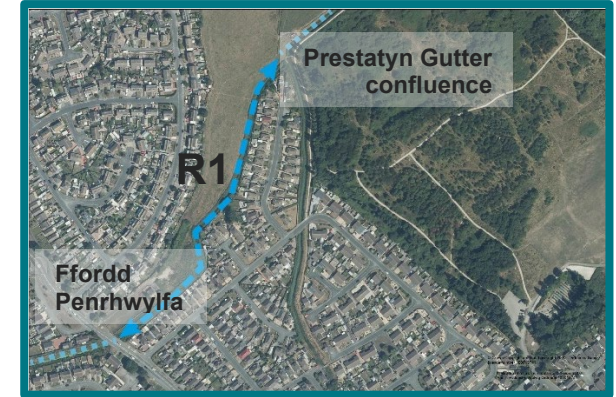
Rhyl Cut R1

Main River Flood Risk Summary	The river generally flows towards Ffordd Penrhwyfya and on to Rhyl pumping station, but can discharge through a flapped outfall into Prestatyn Gutter. There is no significant flood risk to properties from Rhyl Cut in this reach.
Current River Condition	The river is currently in good (if unnatural) condition with channel clearance undertaken relatively frequently.
Maintenance Impacts	Maintaining the river channel in this reach has minimal impact on main river flooding but drainage could be affected by silt levels. The flap valve at the confluence will continue to be maintained in case of an exceptional situation when the water level in Rhyl Cut gets higher than in Prestatyn Gutter.

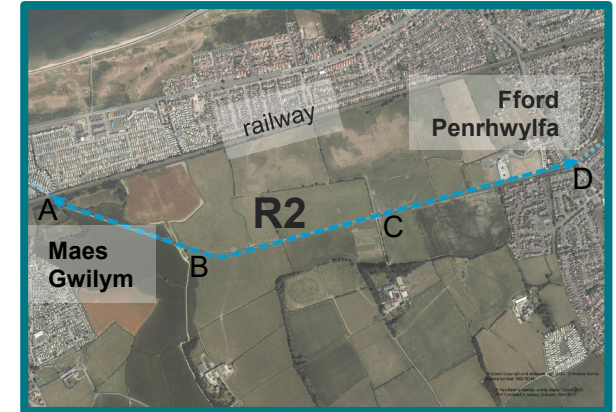
Rhyl Cut R2

Main River Flood Risk Summary	There is no significant flood risk to properties from Rhyl Cut but there is flooding of farmland, in particular to the south of the cut. Properties around Maes-Y-Gog and Lon Hedyn are at risk of flooding from Maes Gwilym (MG) drain.
Current River Condition	Rhyl Cut is currently in good (if unnatural) condition with channel clearance undertaken relatively frequently. There can be substantial invasive weed growth. There could be significant benefits if the river was restored to a more natural state. Maes Gwilym drain is currently in reasonably good condition, except for a culvert under the railway which is partially collapsed (see impact below).
Maintenance Impacts	Maintaining the Rhyl Cut in this reach has no significant impact on property flooding from the main river. Reducing maintenance will lead to some additional flooding of farmland to the south and north of the cut. Drainage could be affected by silt levels. Maes Gwilym drain channel vegetation and raised bed levels increase flood risk. Maes Gwilym drain railway culvert increases flood risk downstream and will therefore not be maintained.

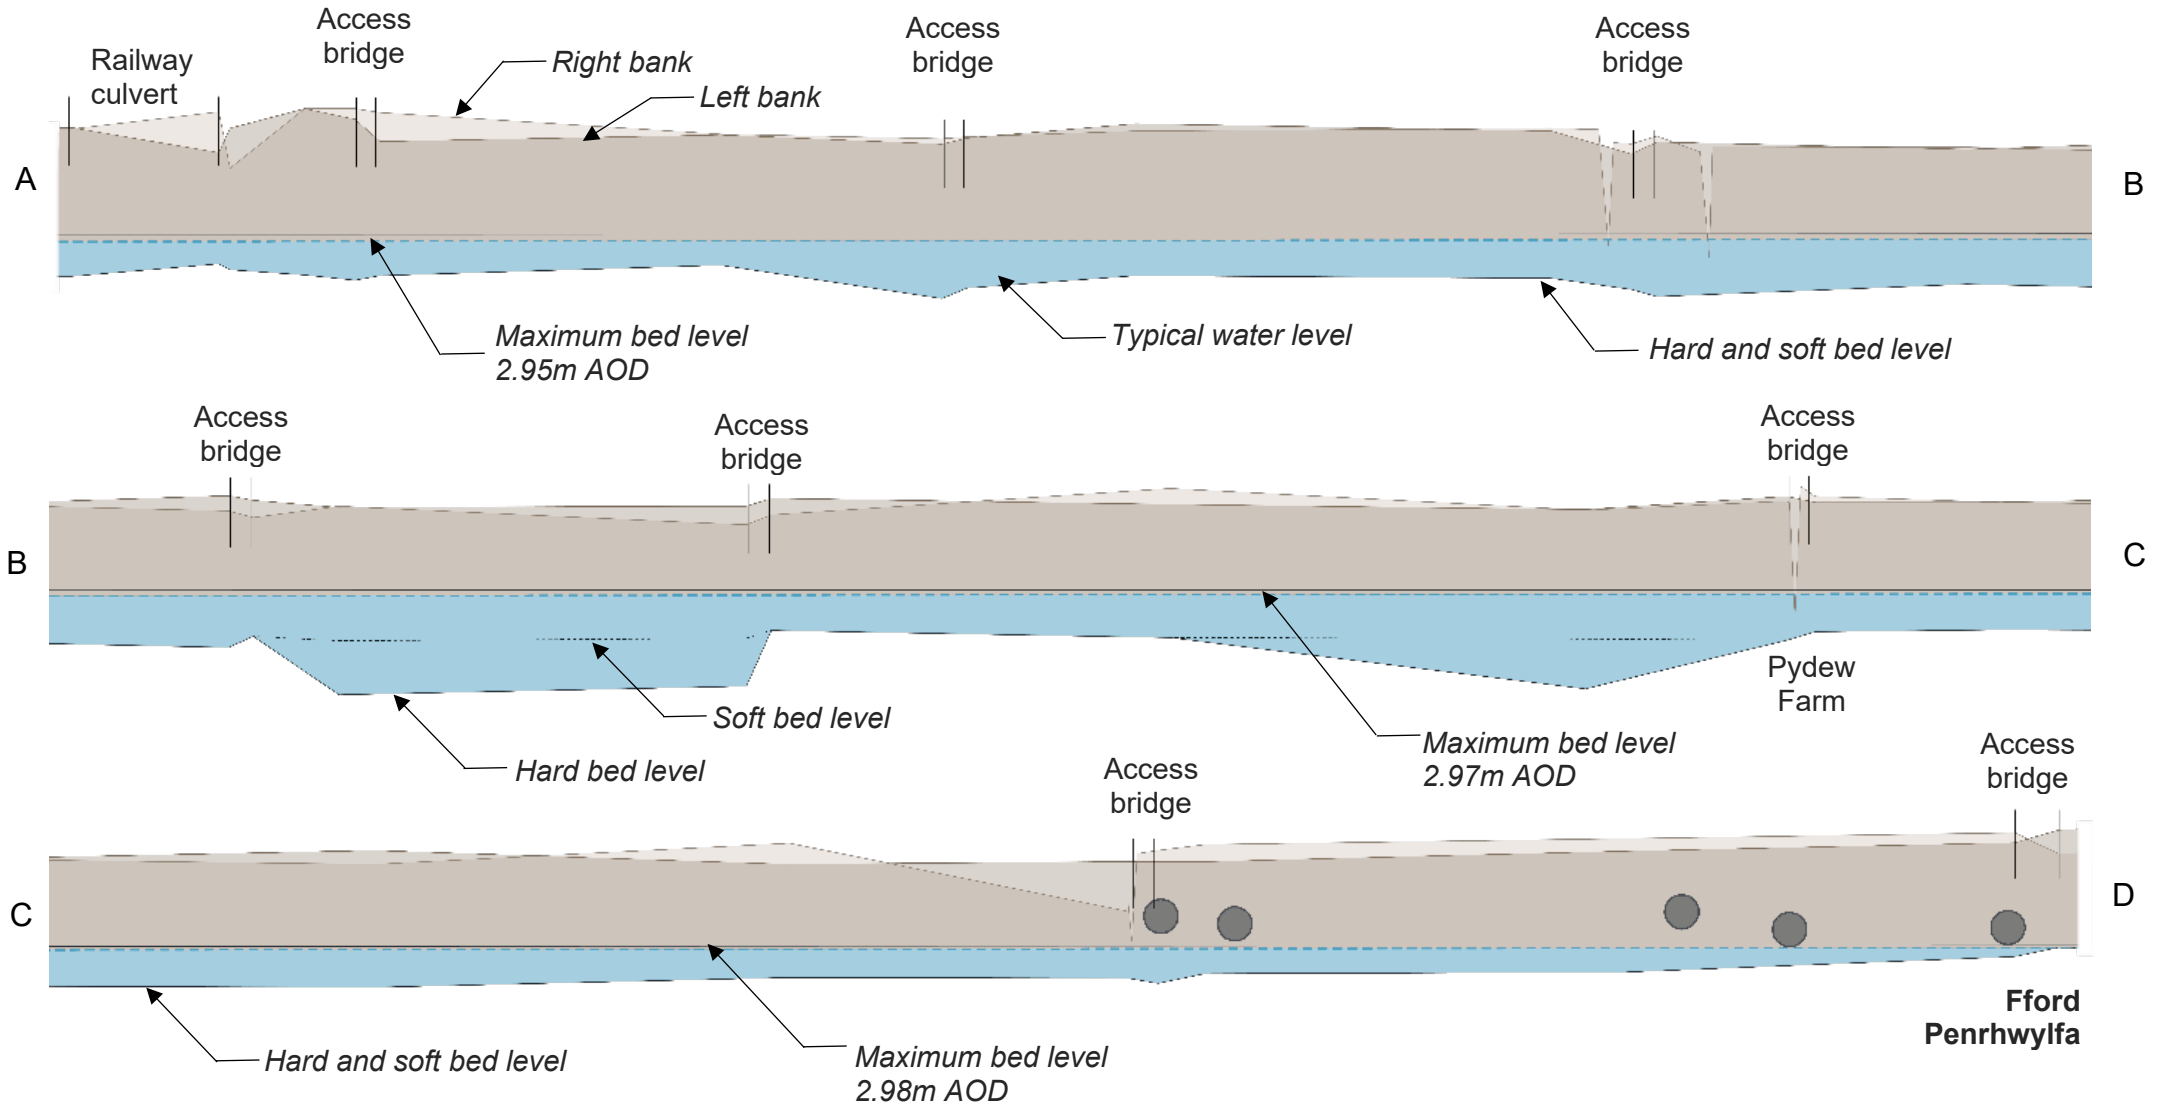
Rhyl Cut R2 Long Section

No long section available for Maes Gwilym drain. Max bed level to minimise reduction in capacity of culverts and other crossings.

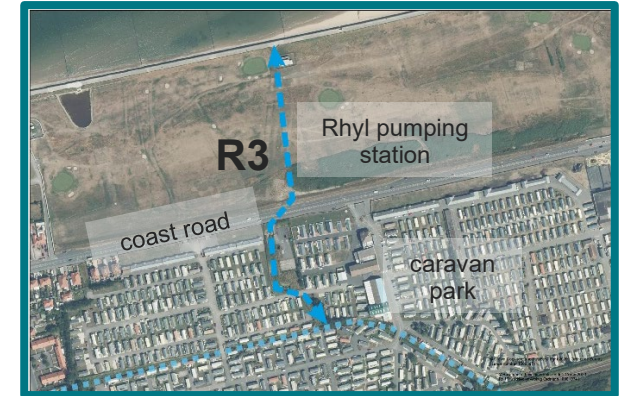
Rhyl Cut R3

Main River Flood Risk Summary	There is no significant risk of flooding from Rhyl Cut in this reach but high water levels could affect properties in reach R4. A few caravans are at risk of flooding during infrequent floods (above approximately 1 in 30 annual chance).
Current River Condition	The river is currently in good condition with channel clearance undertaken relatively frequently. The left hand bore of the Ash Grove culvert upstream is partially blocked but the culvert has spare capacity.
Maintenance Impacts	Rhyl Pumping Station will continue to be operated and maintained (subject to pumping station review and impact of set-back sea defences), as it reduces flood risk to a large area and lots of properties. Maintaining the river channel in this reach has minimal impact on main river flooding but some clearance is required for Rhyl pumping station to operate effectively. Drainage could also be affected by silt levels.

No long section available for Rhyl Pumping Station leg. Max bed level of 2.13m AOD at pumping station culvert inlet (50mm above pumping station debris screen lip); max bed level of 2.32m AOD in at least one pipe of the Ash Grove culvert (200mm above invert).

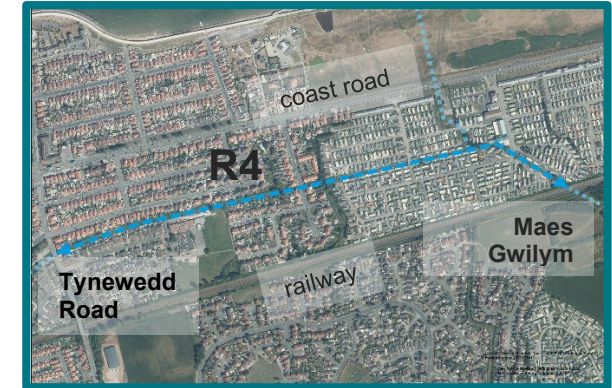
Rhyl Cut R4

Main River Flood Risk Summary	The highest point of Rhyl Cut is near Brynhedydd Road and can therefore flow in both directions along this reach. Properties near Brynhedydd Road and Edgbaston Road and some caravans are at risk of flooding during infrequent floods (above approximately 1 in 30 annual chance) from both Rhyl Cut and Fron Hall drain.
Current River Condition	This reach of Rhyl Cut and Fron Hall drain are in fair condition but there has been siltation between Tynewydd Road and Brynhedydd Road which requires clearance. Maintenance is difficult due to poor access in some locations along both watercourses.
Maintenance Impacts	Maintaining conveyance along this reach of Rhyl Cut slightly reduces the extent of flooding and reduces peak water levels, which may benefit incoming drainage; drainage could also be affected by silt levels. Channel vegetation and raised bed levels along Fron Hall drain increases flood risk.

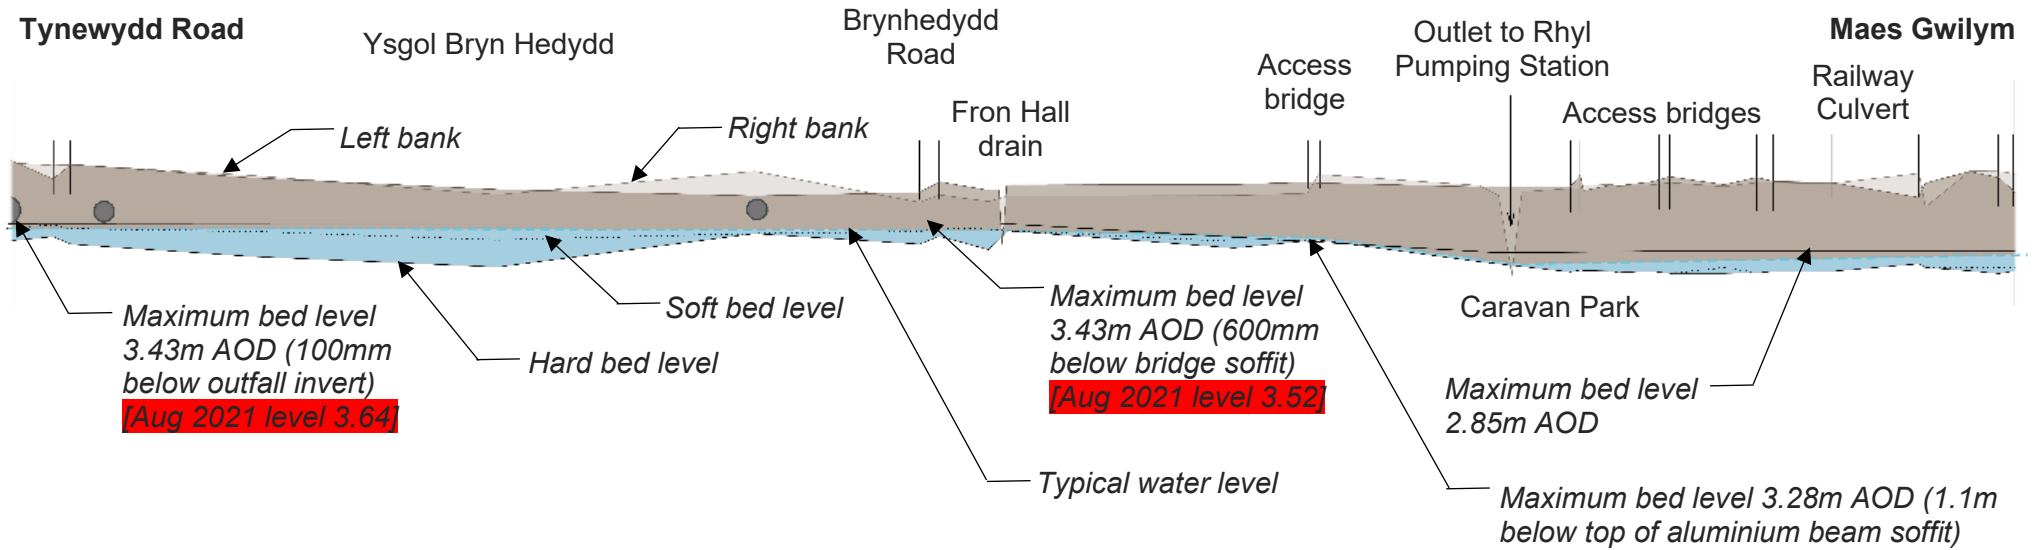
Rhyl Cut R4 Long Section

No long section available for Fron Hall drain. Max bed level to minimise reduction in capacity of culverts and other crossings.

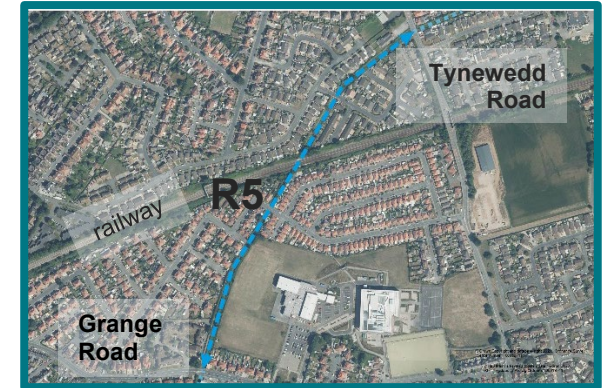
Rhyl Cut R5

Main River Flood Risk Summary	There is no significant risk of flooding from Rhyl Cut in this reach.
Current River Condition	The river is in fair condition along this reach but there has been siltation in places between Tynewydd Road and Grange Road which requires clearance. Maintenance is difficult due to poor access in some locations.
Maintenance Impacts	Maintaining the river channel in this reach has no significant impact on the extent of flooding but does reduce peak water levels, which may benefit incoming drainage; drainage could also be affected by silt levels.

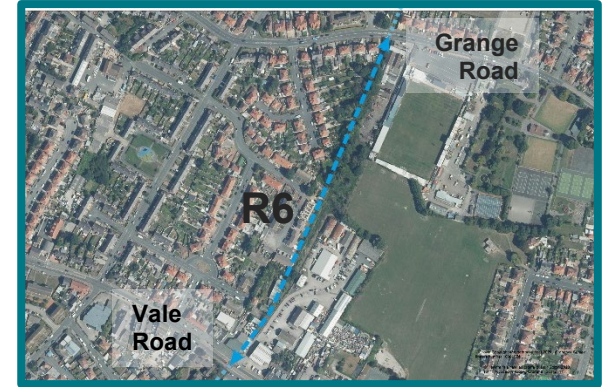
Rhyl Cut R6

Main River Flood Risk Summary	There is no significant risk of flooding from Rhyl Cut along this reach.
Current River Condition	The river is in fair condition along this reach with some siltation downstream of Grange Road. Maintenance is difficult due to poor access in some locations.
Maintenance Impacts	Maintaining the river channel in this reach has no significant impact on the extent of flooding but does reduce peak water levels, which may benefit incoming drainage.

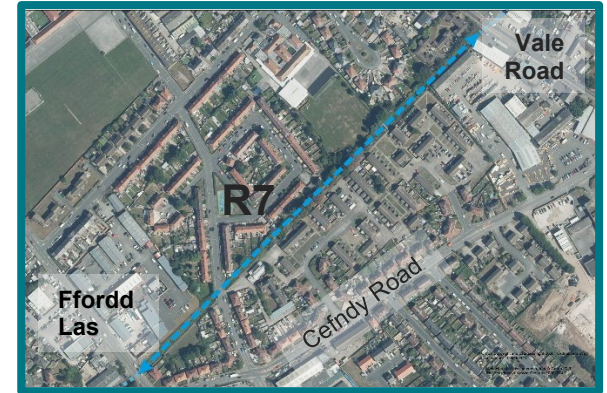
Rhyl Cut R7

Main River Flood Risk Summary	Kingsley Avenue and Walford Avenue are at risk of flooding from Rhyl Cut in this reach, and high water levels in Rhyl Cut are likely to affect incoming drainage.
Current River Condition	The river is in fair condition along this reach with some siltation (not shown on survey section). Maintenance is difficult due to poor access in some locations.
Maintenance Impacts	Maintaining conveyance along this reach of Rhyl Cut slightly reduces the extent of flooding and reduces peak water levels, which may benefit incoming drainage; drainage could also be affected by silt levels.

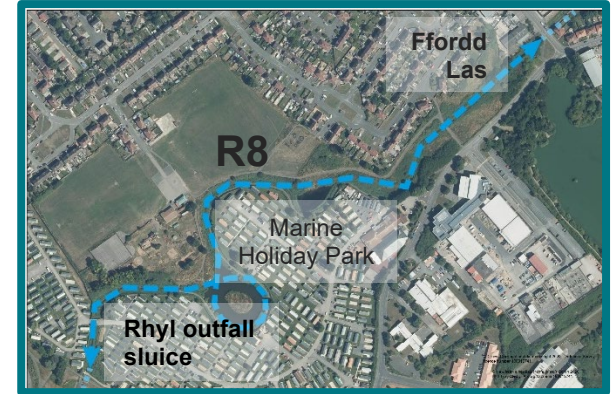
Rhyl Cut R8

Main River Flood Risk Summary	There is no significant risk of flooding from Rhyl Cut in this reach.
Current River Condition	The river is in good condition along this reach. Fishponds created upstream of Marine Camp Sluice rely on elevated water levels downstream.
Maintenance Impacts	Maintaining the river channel in this reach has no significant impact on the extent of flooding but slightly reduces peak water levels. Silt levels could affect drainage.

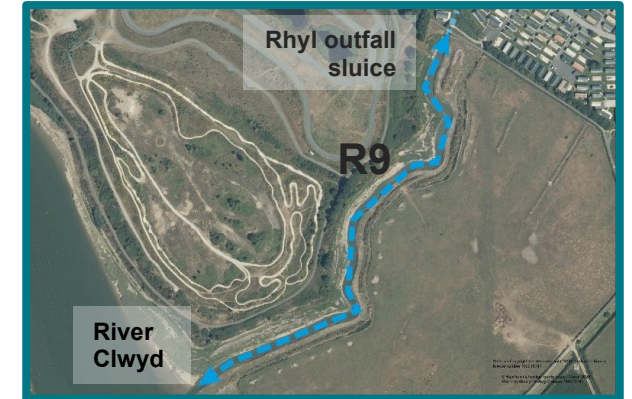
Rhyl Cut R9

Main River Flood Risk Summary	Reach situated in tidal flood plain.
Current River Condition	The river is in fair condition along this reach but clearance is required. Fishponds created upstream of Marine Camp Sluice rely on elevated water levels downstream.
Maintenance Impacts	Siltation of the channel in this reach due to tidal ingress has a significant impact on water levels upstream. Minimum bed level ~2.1m AOD to avoid draining ponds.

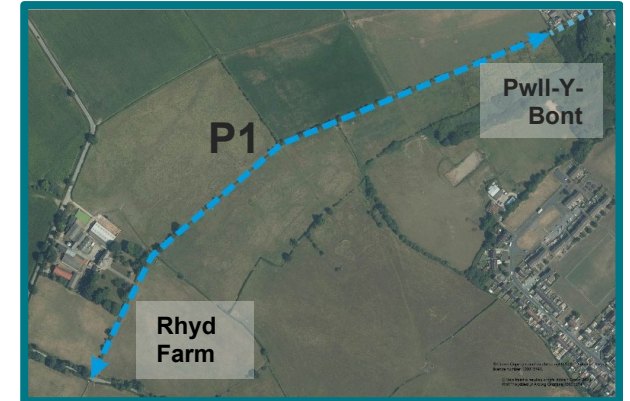
Prestatyn Gutter P1

Main River Flood Risk Summary	There is no flood risk to properties from Prestatyn Gutter in this reach, with some short-duration localised flooding of farmland.
Current River Condition	The river is in fair condition but could be restored to a more natural state to reduce flood risk downstream.
Maintenance Impacts	Maintaining the river channel in this reach has no impact on property flooding in this area and could increase the risk of flooding downstream.

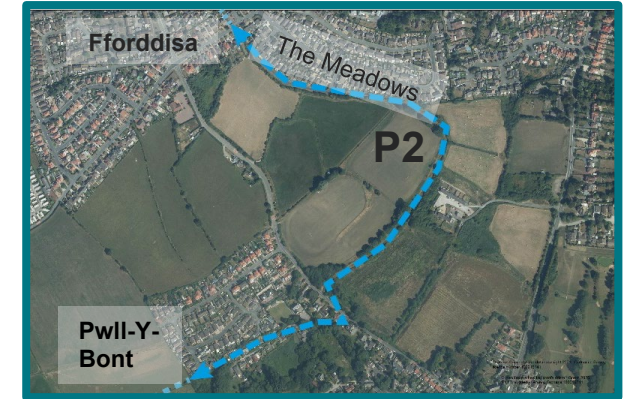
Prestatyn Gutter P2

Main River Flood Risk Summary	Pwll-Y-Bont, Heather Crescent and The Meadows are at significant risk of flooding from Prestatyn Gutter and surface water. There is a 1 in 5 annual chance of some fluvial flooding in these areas. High river levels could also exacerbate surface water flooding in various places including the Llys Farm development.
Current River Condition	The river is generally in good condition along this reach, with some localised siltation around driveway culverts at Pwll Y Bont and the footbridge at The Meadows.
Maintenance Impacts	Maintaining the river channel in this reach (downstream of timber footbridge) is important to minimise flood risk, especially at Pwll-Y-Bont and The Meadows. Maintenance is less critical between Ffordd Penrhwyfya and The Meadows.

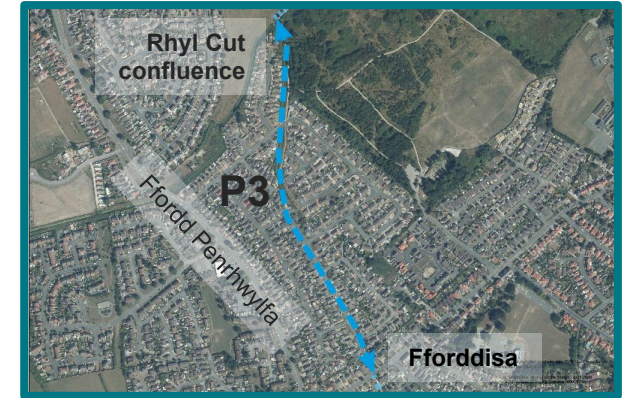
Prestatyn Gutter P3

Main River Flood Risk Summary	Properties around Winchester Drive are at significant risk of flooding from Prestatyn Gutter. Properties around Chichester Drive and Bangor Crescent are also at risk.
Current River Condition	The river and culvert are generally in good condition along this reach, with some localised siltation from Fforddisa culvert to Rhyl Cut confluence.
Maintenance Impacts	Maintaining the river channel in this reach is important to minimise flood risk in this area and also upstream along P2.

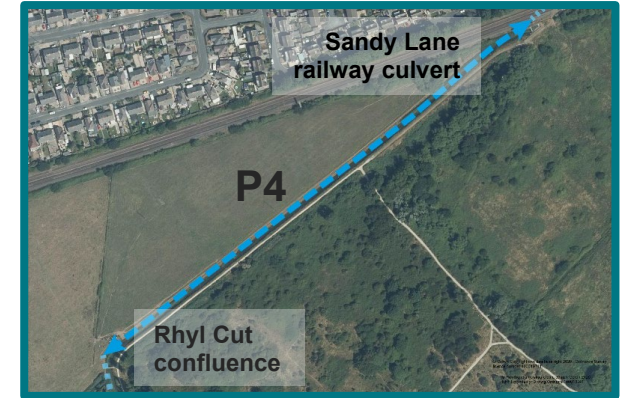
Prestatyn Gutter P4

Rhyl Cut to Sandy Lane railway culvert

Main River Flood Risk Summary	There are no properties along this reach but high water levels in Prestatyn Gutter can increase flood risk upstream along P3.
Current River Condition	The river is in fair condition with some siltation along the whole reach, which may require clearance up to and including the railway culvert (subject to assessment).
Maintenance Impacts	Maintaining the river channel in this reach is relatively important to minimise flood risk upstream along P3, as raised water levels slightly increase levels upstream.

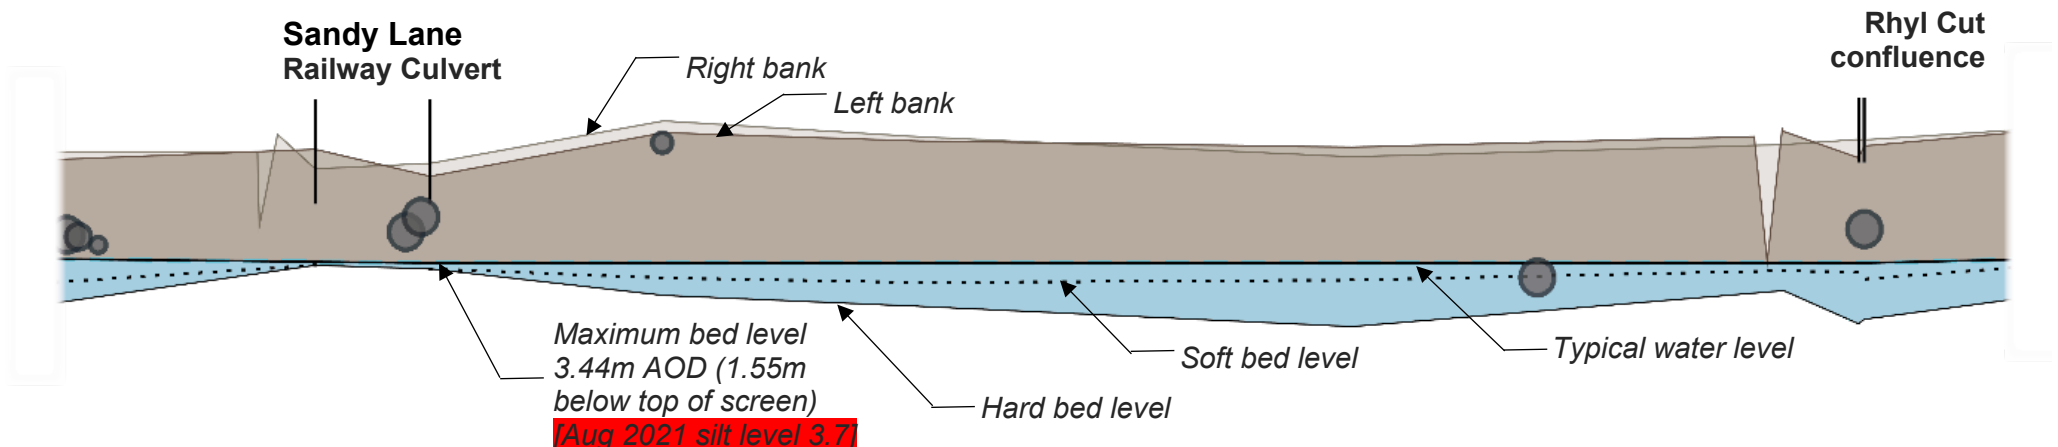
Survey and assessment of railway culvert required to confirm max bed levels (in conjunction with Network Rail)

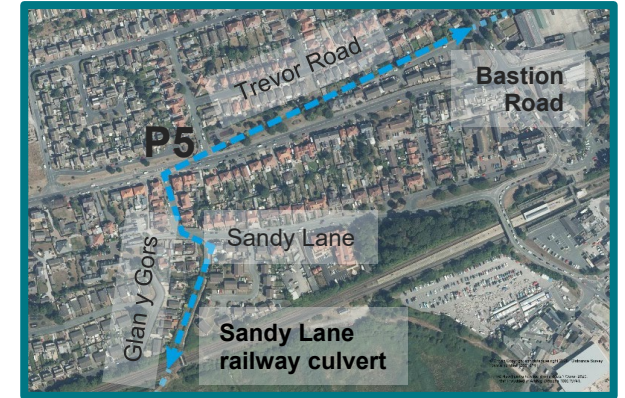
Prestatyn Gutter P5

Sandy Lane Railway Culvert to Bastion Road

Main River Flood Risk Summary	Properties around Glan y Gors and Trevor Road are at significant risk of flooding from Prestatyn Gutter, surface water, and railway drainage (Glan y Gors only).
Current River Condition	The river is in fair condition along this reach, with some siltation around Sandy Lane, which may require clearance (subject to survey and assessment).
Maintenance Impacts	Maintaining the river channel in this reach is important to minimise flood risk, although vegetation growth only has a small impact on flood extent and water levels.

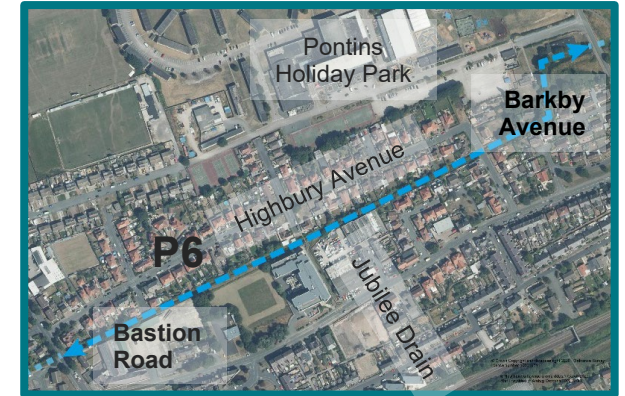
Bastion Road to Barkby Avenue

Main River Flood Risk Summary	There are no properties at significant risk of flooding from Prestatyn Gutter, but the Pontins Holiday Park could be affected by infrequent floods (above approximately 1 in 30 annual chance). Jubilee Drain not modelled.
Current River Condition	The river is generally in good condition along this reach.
Maintenance Impacts	Maintaining the river channel in this reach is important to minimise flood risk in this area and upstream in P5.

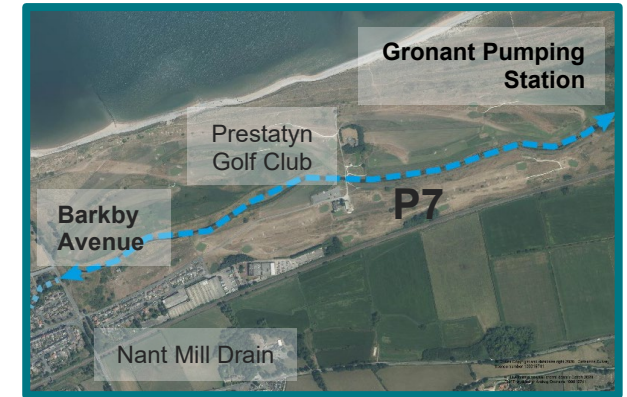
Prestatyn Gutter P7

Barkby Avenue to Gronant Pumping Station

Main River Flood Risk Summary	Flooding in this reach only effects the golf course. Nant Mill Drain not modelled.
Current River Condition	The river is generally in good condition along this reach and has historically been maintained to an unnecessarily high standard.
Maintenance Impacts	Maintaining the river channel in this reach has little impact on flood risk but some clearance is required for Gronant pumping station to operate effectively. Maintenance can also affect flooding in reach P6.
